Spot Safety Project Evaluation

Spot Safety Project # 10-96-213

**Spot Safety Project Evaluation of the Traffic Signal Installation
At the Intersection of SR 3468 (Weddington Rd) and SR 3448 (Pleasants
Plains/S. Trade St)
Mecklenburg County**

Safety Evaluation Group
Traffic Safety Systems Management Section
Traffic Engineering and Safety Systems Branch
North Carolina Department of Transportation

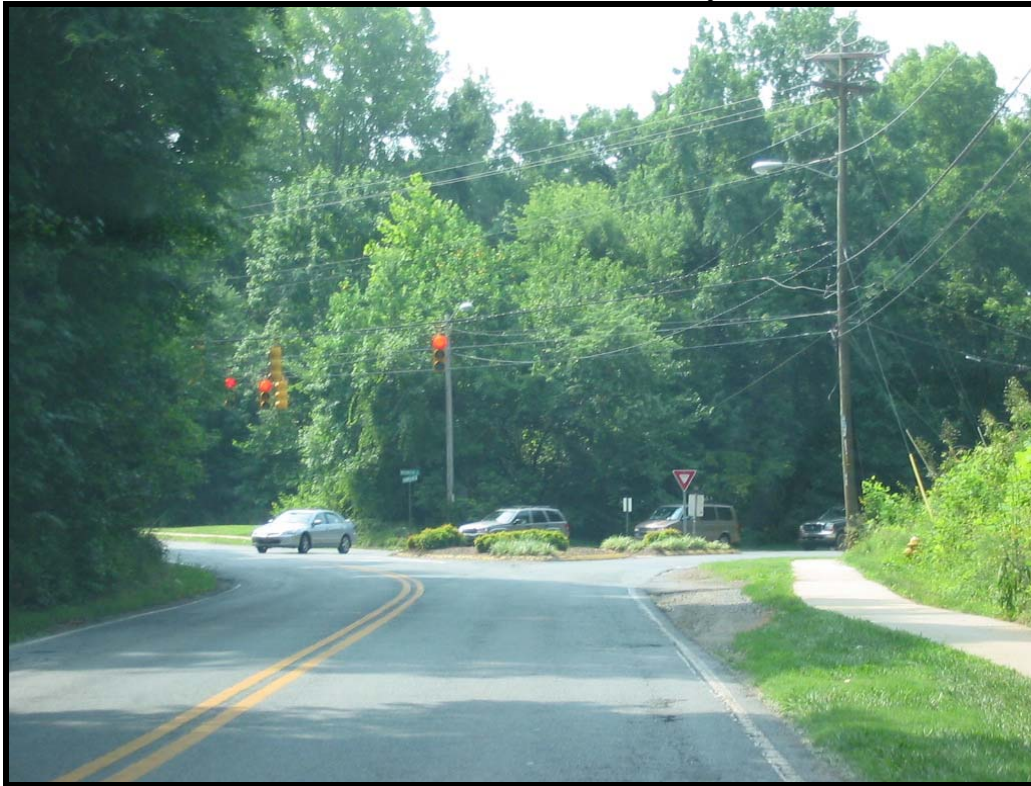
Traveling South on SR 3448 (S. Trade St)

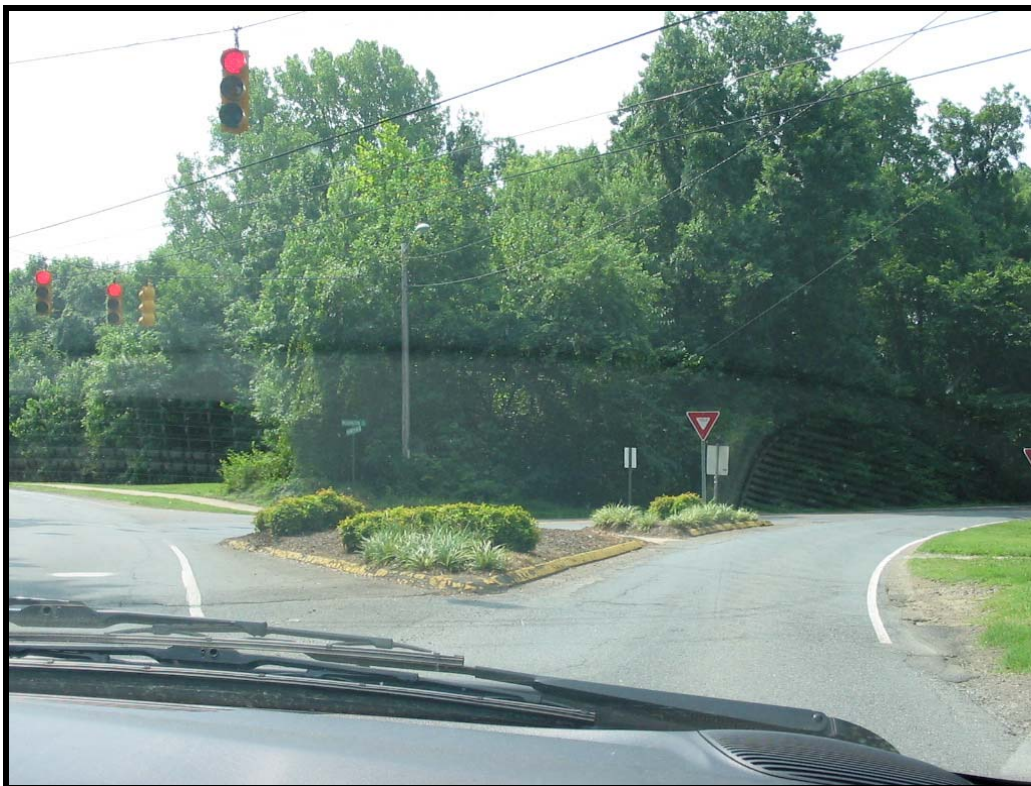
Traveling South on SR 3448 (S. Trade St)

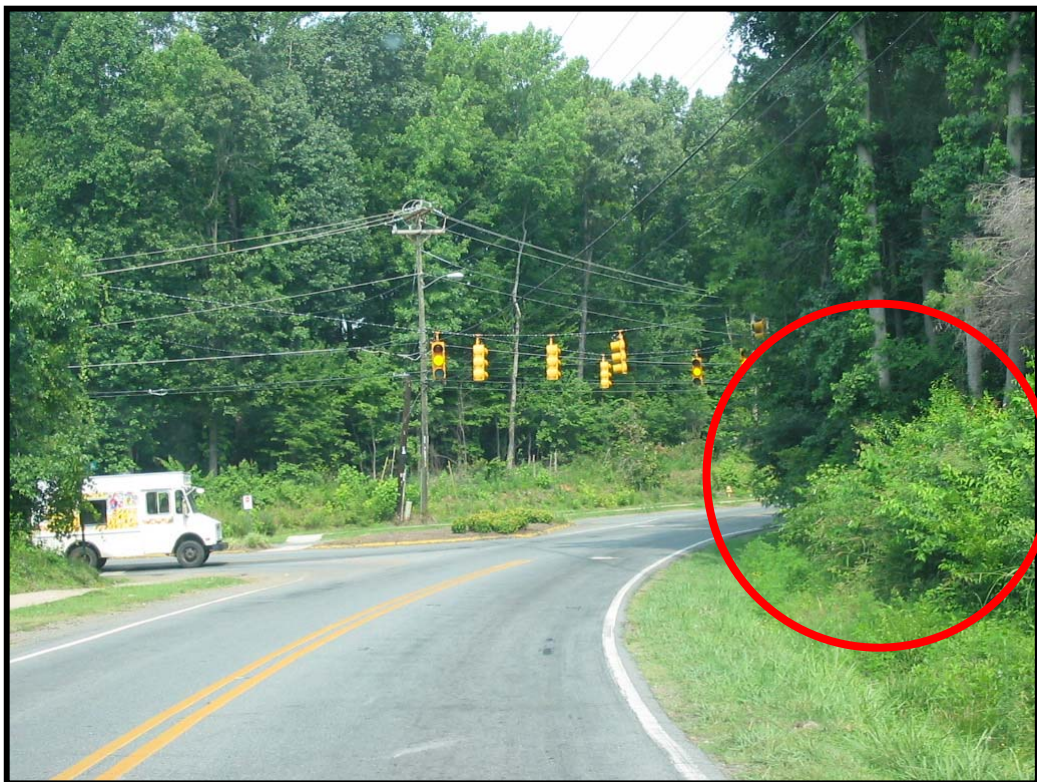
There is a curve in the roadway just before the intersection on the northwest approach of SR 3448. Trees on the roadside along the curve limit site distance approaching the intersection.

Traveling North-West on SR 2448 (Pleasant Plains Rd)
Notice the limited site distance due to the curve and trees

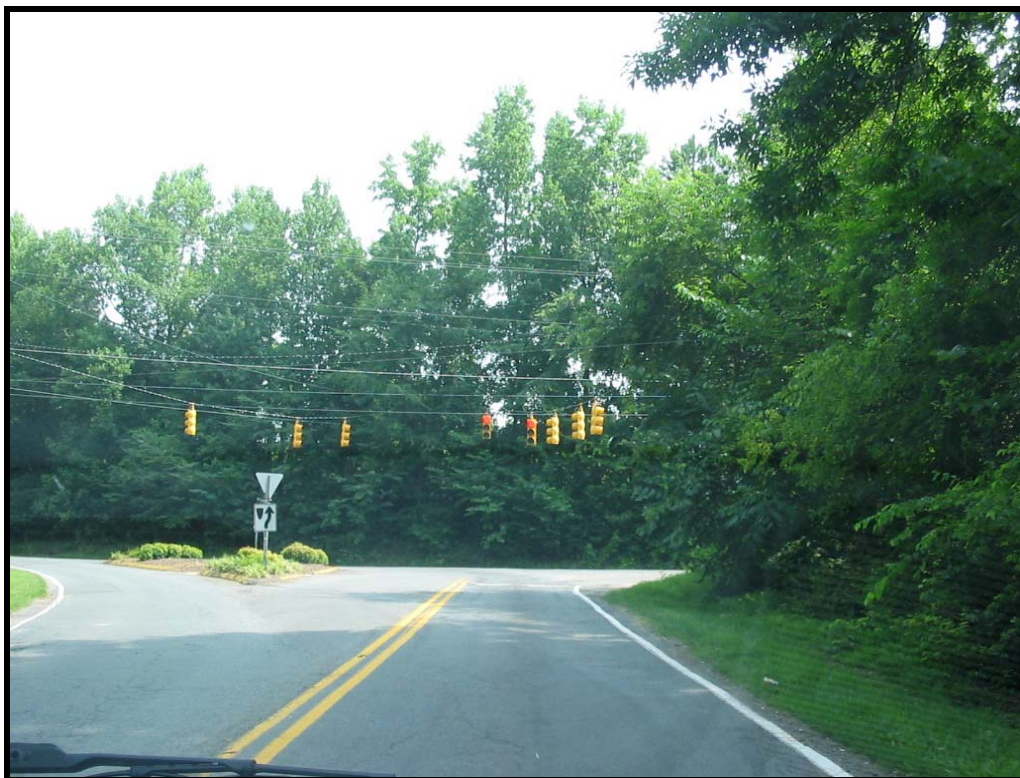
Traveling East on SR 3468 (Weddington Rd)

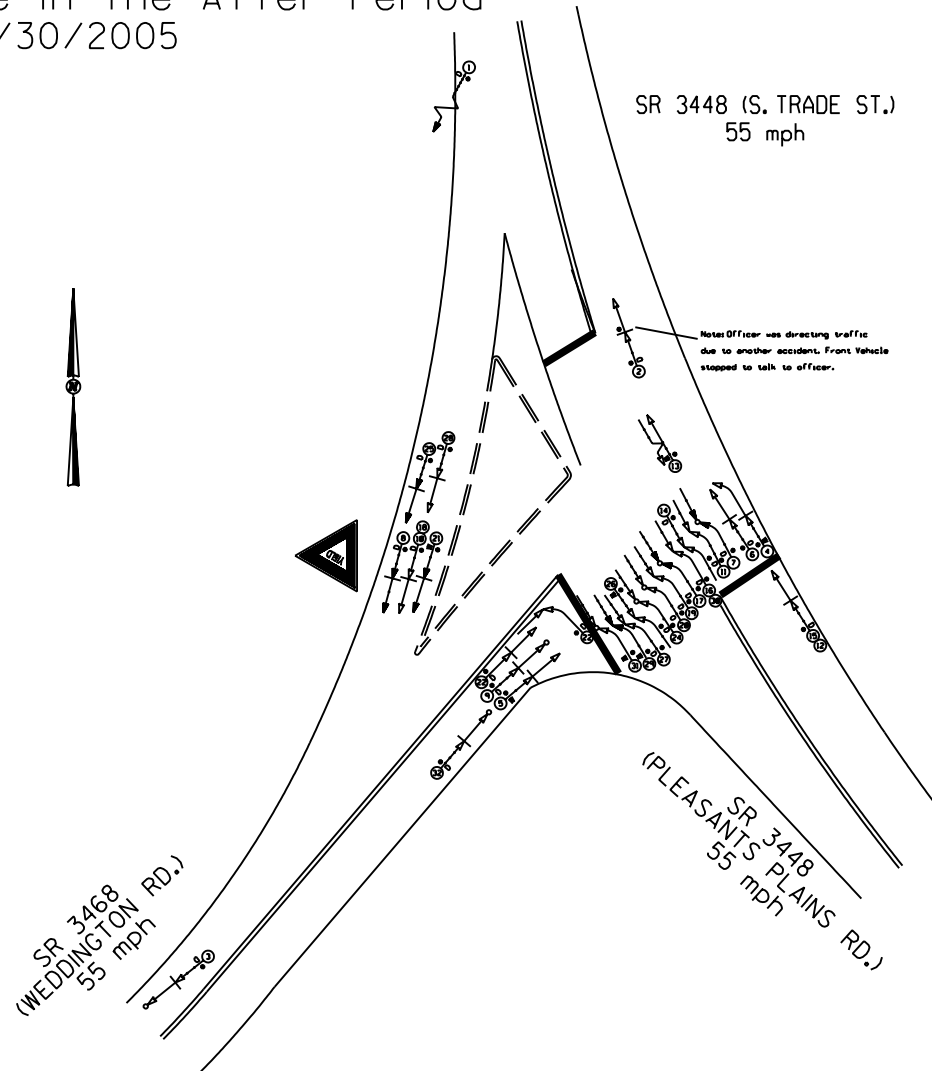
Mecklenburg County
 SR 3448 (Pleasant Plains Rd/
 S. Trade St) at SR 3468 (Weddington Rd)
 Treatment Site in the After Period
 From 1/1/1998-9/30/2005

A new crash pattern of Left Turn-Same Roadway Crashes involving northbound SR 3448 vehicles turning left onto SR 3468 emerged after the signal was installed. While only three such crashes occurred in the before period, 13 occurred in the after period. There is limited site distance on the northern approach to the intersection (as described in the *Project Background* section). In addition, the installation of the signal might contribute to drivers paying less attention to oncoming vehicles. In two crash reports, it was explicitly stated that the left-turning driver thought that they had the right-of-way.

Rear-End crashes at the intersection have also increased from the before to the after period, especially on SR 3468. Rear-End crashes increased 300 percent (from 1 to 4) on SR 3468 from the before to the after period.

Rear-End crashes on the right-turn slip ramp from SR 3448 to SR 3468 also increased (from 3 to 6) from the before to the after period. This increase could possibly be due to southbound right-turning drivers seeing that they have the green signal and not realizing they might have to yield to northbound left-turning traffic. It is also possible that some drivers do not understand the yield sign controlling the slip ramp, and are therefore stopping when they do not need to.
